Sewer Consultants

High Definition Sewer Inspections

Diagnostic Report:

Prepared for: SAMPLE
Property Address: SAMPLE
Inspected by: Charlie Clayton
Prepared on: 1/1/2018

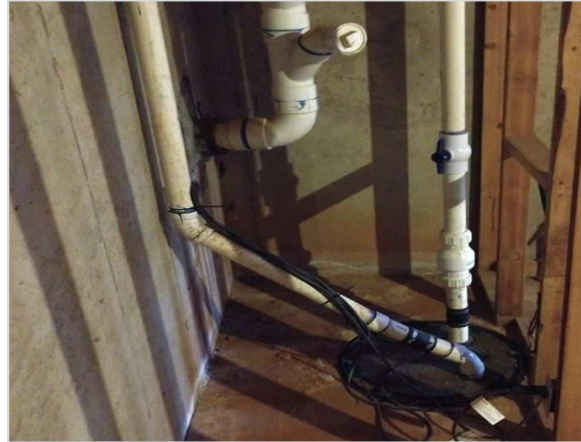
Sewer camera inspection was performed on 1/1/2018 at 123 Sample Street. Sewer camera was run from the 4" plumbing cleanout located in the basement and a combination of PVC and cast-iron piping was observed. A separate 3" cleanout was present in the same area and the threads of both cleanouts were sealed with plumbers' putty, which is not recommended.

Cleanout in Basement

The drain line is not operating properly and should be further evaluated by a licensed professional for repair or replacement. Cleanouts should be placed no more than 100ft apart, so we recommend installing an additional cleanout outside of the home. Cleanout caps are designed to be gas and water tight, so plumbers' putty should not be needed. Putty should be removed from both cleanout caps. If gas or smells escape, we recommend replacing the cleanout caps. From ~18ft to ~31ft, the cast-iron drain line needs to be replaced. We recommend replacing all cast-iron piping with PVC. The PVC piping between ~31ft to ~38 ft is also bellying and should be repaired or replaced as needed.

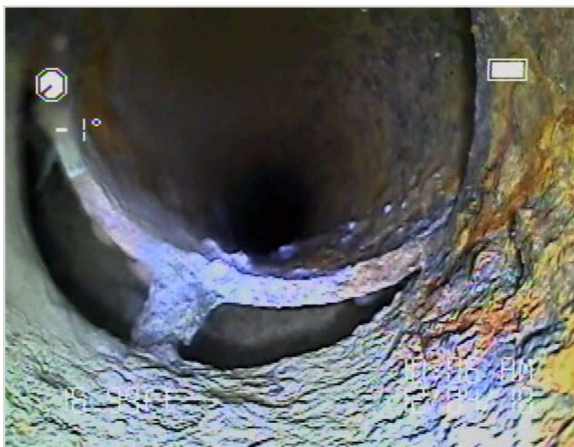
The cleanout itself made with PVC piping and transitions to cast-iron piping ~4ft from the entry point. The drain line is in fair condition until ~18ft. At ~18 ft, the drain pipes separate allowing waste to drain outside of the piping causing an unknown amount corrosion to the ground/soil. Inside the piping, excessive scale is present throughout the remaining area of cast-iron piping, from ~18ft to 31ft. At ~31ft, cast-iron piping transitions back to PVC. The drain line is bellying, or sagging, from ~30ft to ~38ft causing standing water and some backup. The remaining inspected portion of the drain line appeared to be in working condition. The camera was run its full length of 100ft and did not reach the city sewer connection.

Pipes Separated - ~18ft

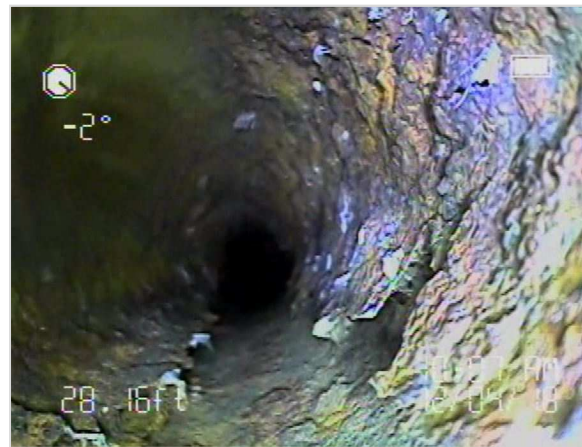
Cast-Iron – Poor Condition - ~28ft

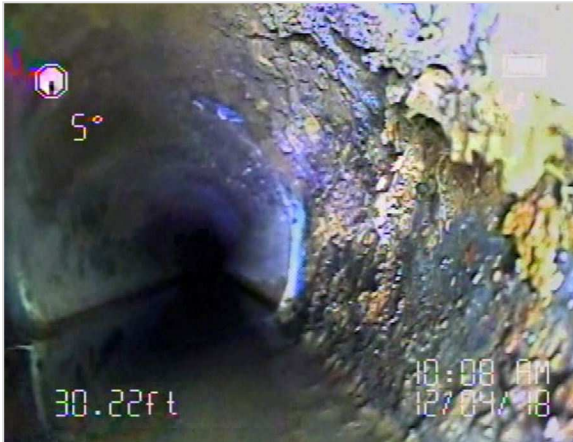
Transition to PVC – Standing Water - ~31ft

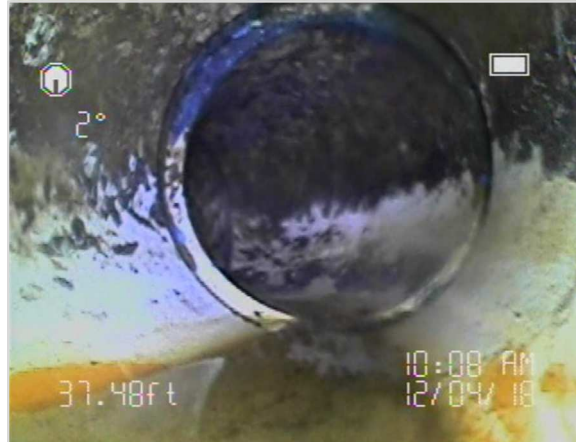
Standing Water Ends - ~38ft
