Property Inspection Report

111 Morton creek Cir
Johns creek Ga 30022

United We Stand Property Inspections

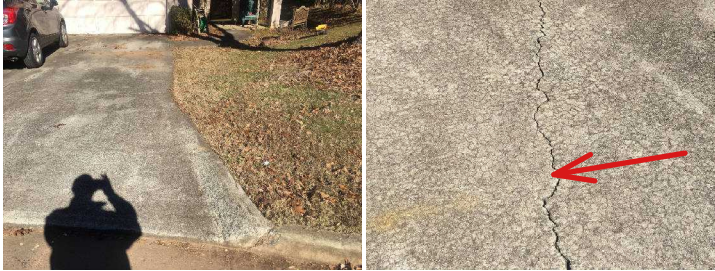
1. ☐☐☐☐☒ Driveway: Concrete - Heavy cracks in surface, Damaged or deteriorated, recommend estimate for repair or replacement by a licensed contractor

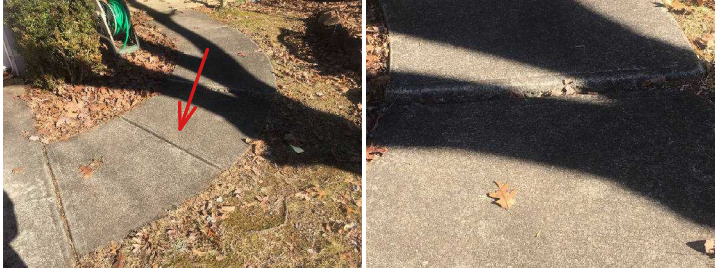
2. ☐☐☐☐☒ Walks: Concrete - Trip hazard

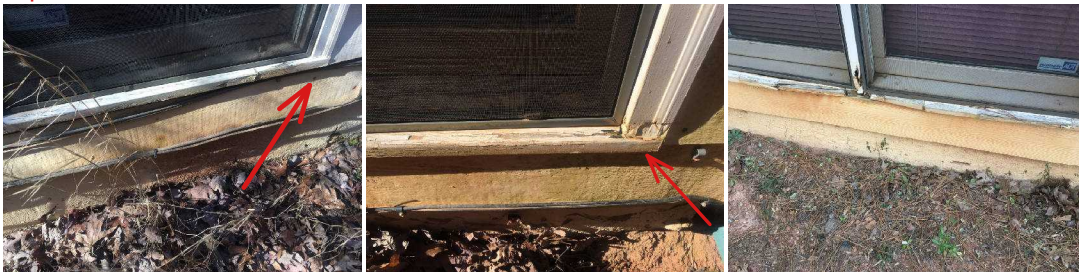
7. ☐ ☐ ☐ ☐ ☒ Windows: Wood double hung - Wood rot is present, a licensed contractor is recommended for repairs.

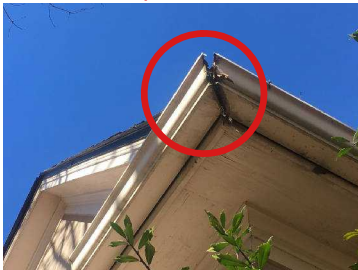
10. ☐ ☐ ☐ ☐ ☒ Gutters: Aluminum - Gutters loose, spikes or straps missing, a licensed contractor is recommended to make repairs.

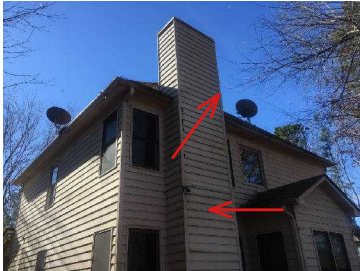
West Chimney

13. ☐☐☐☐☒ Chimney: Framed - A qualified contractor is recommended to evaluate and estimate repairs

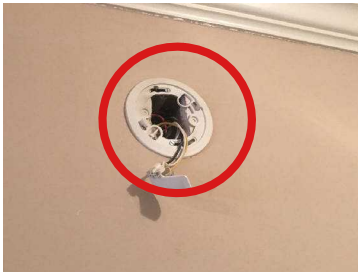
27. ☐ ☐ ☐ ☐ ☒ Smoke Detector: Hard wired with battery back up and light - **Inoperative, Evaluation by a fire alarm certified licensed electrician is recommended**

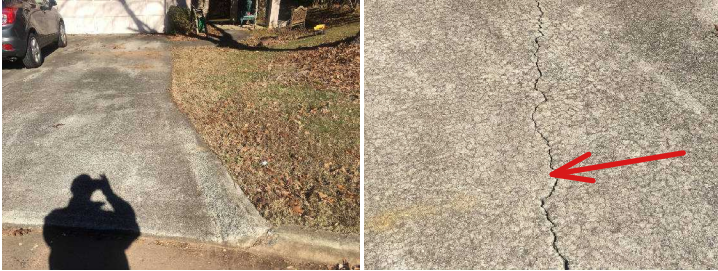
1. Driveway: Concrete - Heavy cracks in surface, Damaged or deteriorated, recommend estimate for repair or replacement by a licensed contractor

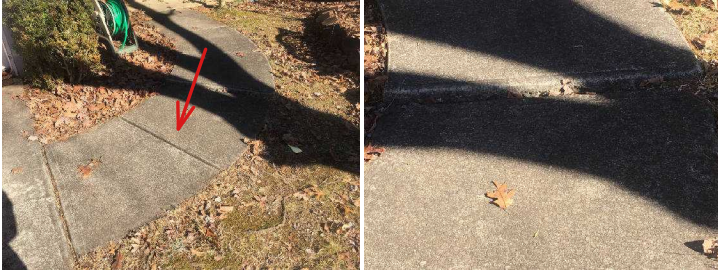
2. Walks: Concrete - Trip hazard

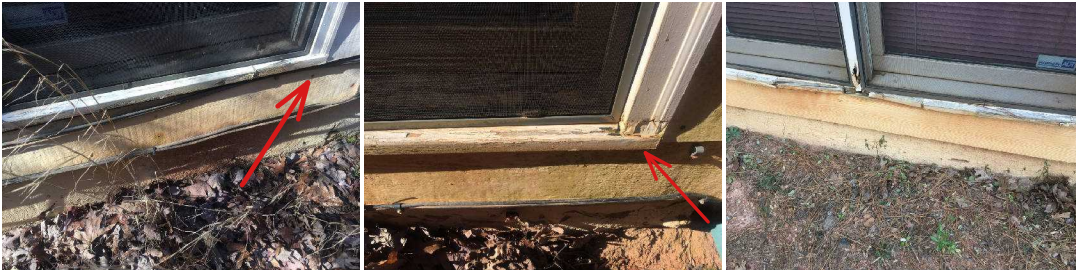
3. Windows: Wood double hung - Wood rot is present, a licensed contractor is recommended for repairs.

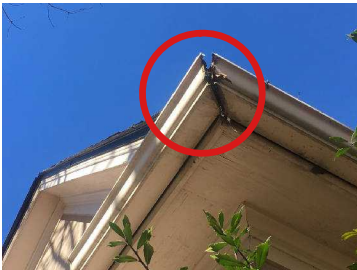
4. Gutters: Aluminum - Gutters loose, spikes or straps missing, a licensed contractor is recommended to make repairs.

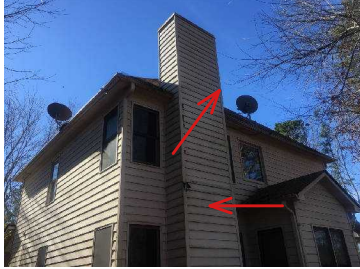
5. West Chimney Chimney: Framed - **A qualified contractor is recommended to evaluate and estimate repairs**

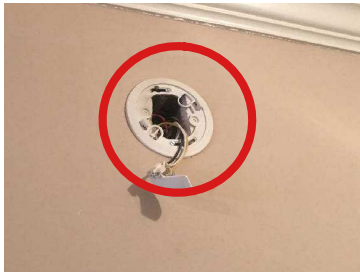
6. Dining Room Living Space Smoke Detector: Hard wired with battery back up and light - **Inoperative, Evaluation by a fire alarm certified licensed electrician is recommended**
