Home Inspection Report

United We Stand Property Inspections

Property Address: [REDACTED]
City: Sugar Hill State: GA Zip: [REDACTED]

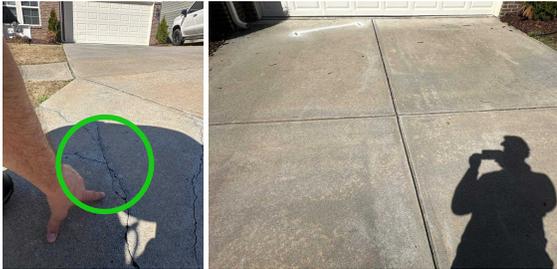
1. Acceptable Driveway: Concrete - A minimal crack was observed in one corner of the driveway. This appears to be a minor cosmetic issue with no immediate concerns. Monitoring for any changes over time is recommended.

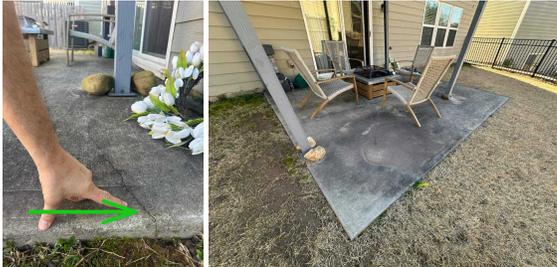
3. Acceptable Patio: Concrete - A minimal crack was observed on concrete patio floor. This appears to be a minor cosmetic issue with no immediate concerns. Monitoring for any changes over time is recommended.

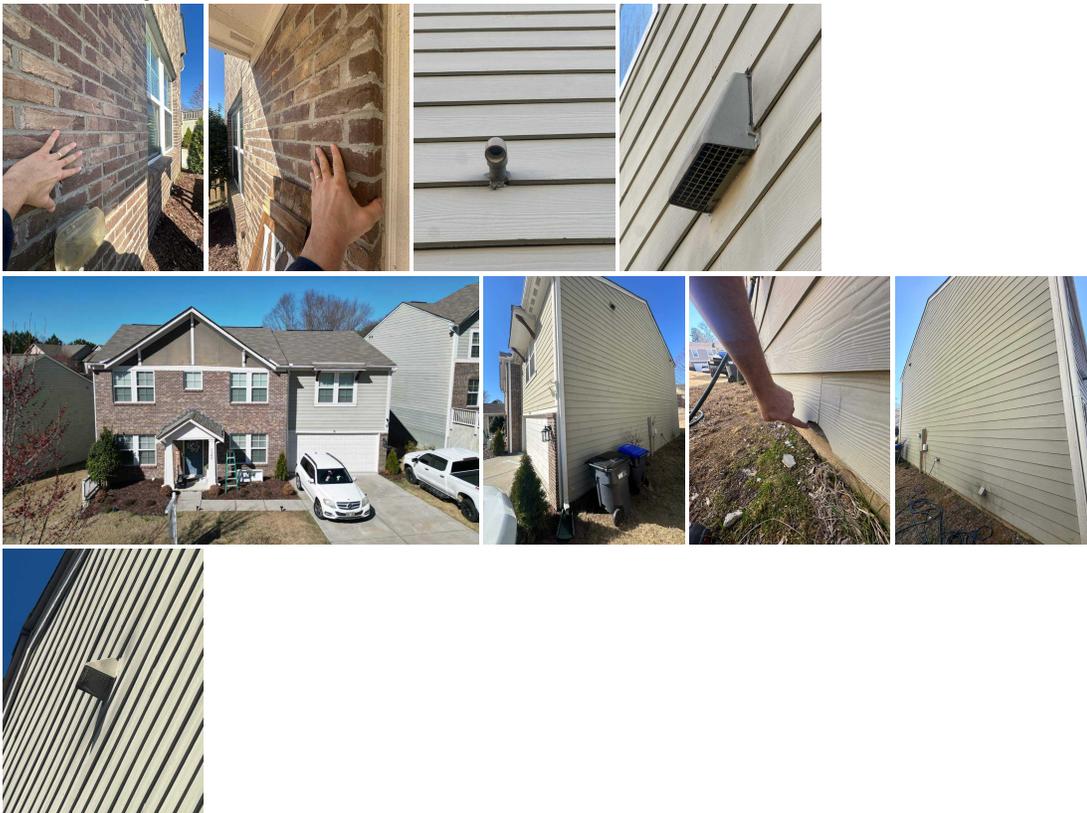
1. Acceptable Type: Cement and fiber (hardiplanks) - A few minor imperfections were observed on the Hardieplank exterior siding, particularly on the bottom boards. These are cosmetic and do not affect functionality. Maintenance can be considered as needed.

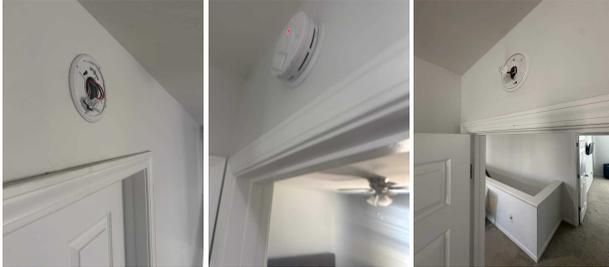
4. Marginal Smoke Detectors: Hard wired - There was no smoke detector in some areas of the house, and at least one was detached from its electrical box. Recommend installing missing detectors and securing any loose ones for safety.

1. Smoke Detectors: Hard wired - There was no smoke detector in some areas of the house, and at least one was detached from its electrical box. Recommend installing missing detectors and securing any loose ones for safety.

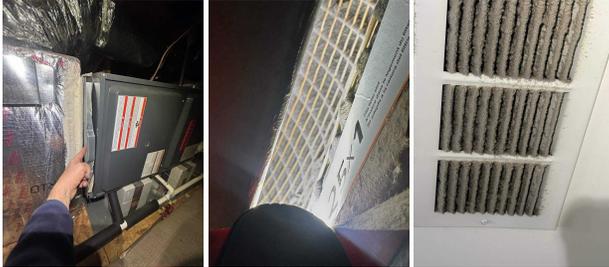
5. Marginal Blower Fan/Filter: Disposable - The air filters were noticeably dirty, and the return vents in the master bathroom had visible dust buildup. The ductwork may also require cleaning due to excessive dust. Recommend having an HVAC contractor evaluate and service as needed.

2. Attic Heating System Blower Fan/Filter: Disposable - The air filters were noticeably dirty, and the return vents in the master bathroom had visible dust buildup. The ductwork may also require cleaning due to excessive dust. Recommend having an HVAC contractor evaluate and service as needed.

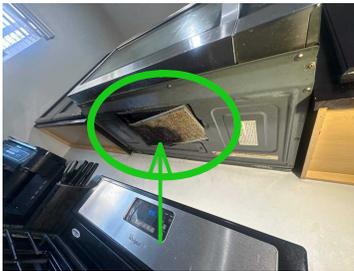
- 2. Marginal Ventilator: On Whirlpool Microwave - Replace filter

3. 1st Floor Kitchen Ventilator: On Whirlpool Microwave - Replace filter

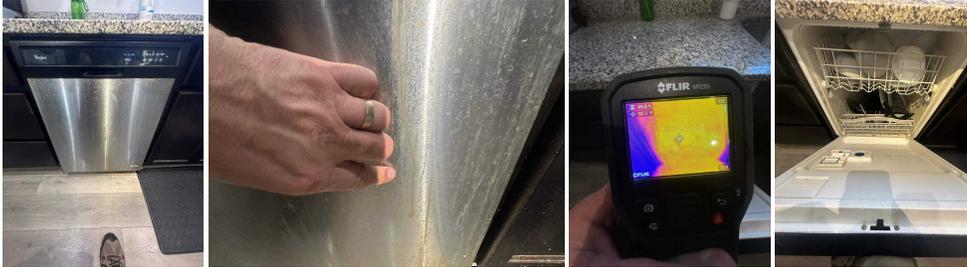
4. Marginal Dishwasher: Whirlpool - The washer's metal surface appears stained and may benefit from professional cleaning. The range oven also shows signs of needing a thorough cleaning. Recommend addressing as needed for better maintenance and appearance.

4. 1st Floor Kitchen Dishwasher: Whirlpool - The washer's metal surface appears stained and may benefit from professional cleaning. The range oven also shows signs of needing a thorough cleaning. Recommend addressing as needed for better maintenance and appearance.

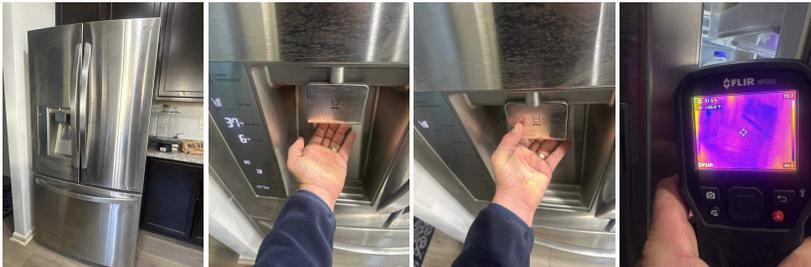
6. Marginal Refrigerator: LG - The refrigerator did not dispense water or ice at the time of inspection. Recommend checking the water supply connection and filter or consulting an appliance specialist if needed.

5. 1st Floor Kitchen Refrigerator: LG - The refrigerator did not dispense water or ice at the time of inspection. Recommend checking the water supply connection and filter or consulting an appliance specialist if needed.

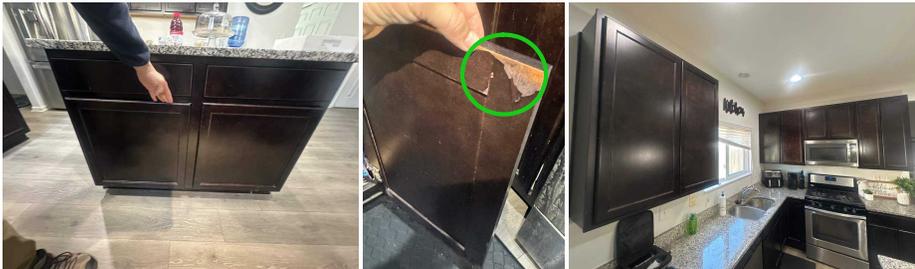
12. Marginal

Cabinets: Laminate - The kitchen laminated cabinets have minor defects, including slight peeling at the corners and no handles installed. These are cosmetic issues, and maintenance or upgrades can be considered as needed.

6. 1st Floor Kitchen Cabinets: Laminate - The kitchen laminated cabinets have minor defects, including slight peeling at the corners and no handles installed. These are cosmetic issues, and maintenance or upgrades can be considered as needed.

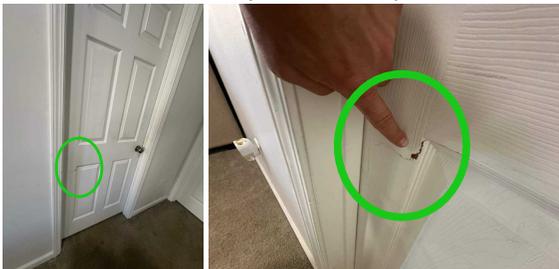
20. Marginal Doors: Hollow wood - The master bedroom door has a crack in the wooden panel. This is a cosmetic issue and can be repaired or replaced if desired.

8. Master Bedroom Doors: Hollow wood - The master bedroom door has a crack in the wooden panel. This is a cosmetic issue and can be repaired or replaced if desired.

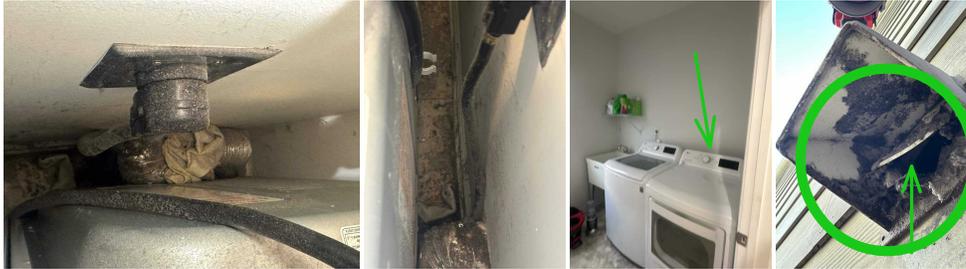
9. Marginal Dryer Vent: Metal flex - The laundry vent appears to be dirty and may need cleaning. Recommend having it cleaned to ensure proper ventilation and prevent potential hazards

10. 1st Floor Laundry Room/Area Dryer Vent: Metal flex - The laundry vent appears to be dirty and may need cleaning. Recommend having it cleaned to ensure proper ventilation and prevent potential hazards
