# Home Inspection Report

Sample Condo Report

# United We Stand Property Inspections

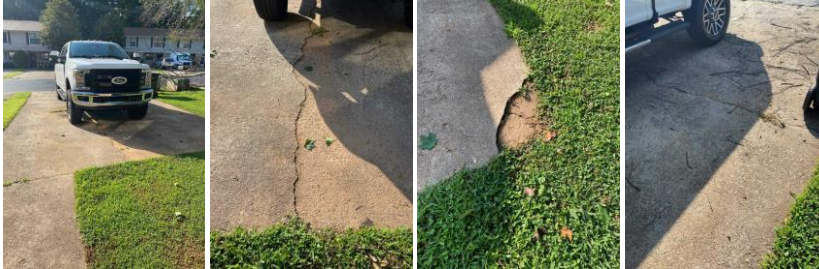
1. Acceptable Driveway: Concrete - Heavy cracks in surface

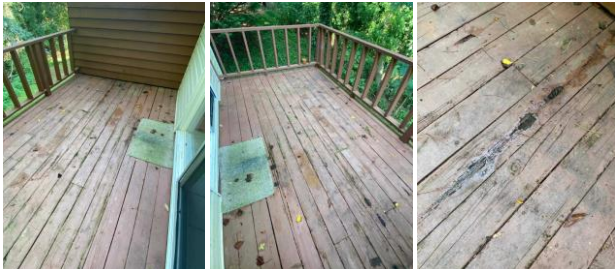
5. Defective Deck: Stained wood - Moisture damage to deck boards. Replacement recommended.

2. Deck: Stained wood - Moisture damage to deck boards. Replacement recommended.

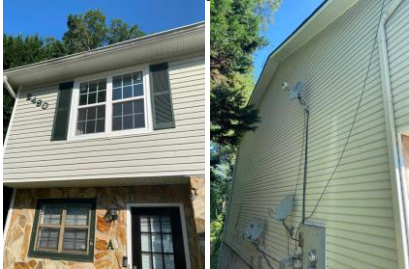
1. Acceptable      Type: Vinyl siding and stone

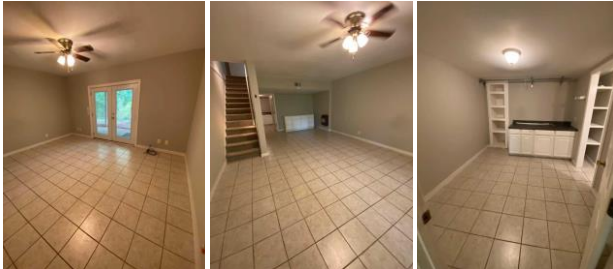
3. Acceptable      Floor: Ceramic tile
4. Not Present      Floor Drain:
5. Acceptable      Doors: Hollow wood
6. Not Present      Windows:
7. Marginal, Defective Electrical: 110 VAC - Light fixture lighting basement stairwell, one of the two lights is not working, as well as the recessed light in the ceiling is not working properly. It will not turn all the way in flickers. Recommend further evaluation by qualified professional.

2. Main Basement Electrical: 110 VAC - Light fixture lighting basement stairwell, one of the two lights is not working, as well as the recessed light in the ceiling is not working properly. It will not turn all the way in flickers. Recommend further evaluation by qualified professional.

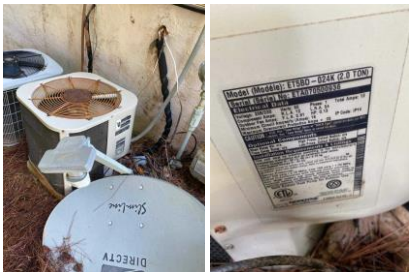
- 1. Acceptable A/C System Operation: Appears serviceable
- 2. Acceptable Condensate Removal: PVC
- 3. Acceptable Exterior Unit: Pad mounted

- 4. Manufacturer: Nordyne
- 5. Model Number: ET5BD-024K Serial Number: ETA070500936
- 6. Area Served: Whole building Approximate Age: 2000
- 7. Fuel Type: 120-240 VAC Temperature Differential: 17\*

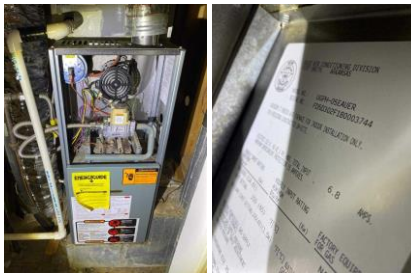
1. Acceptable Heating System Operation: Appears functional
2. Manufacturer: Ruud

3. Model Number: UGPH-05EAUER Serial Number: FD5D302F180003744
4. Type: Forced air Capacity: 50,000 BTUHR
5. Area Served: Whole building Approximate Age: 2000

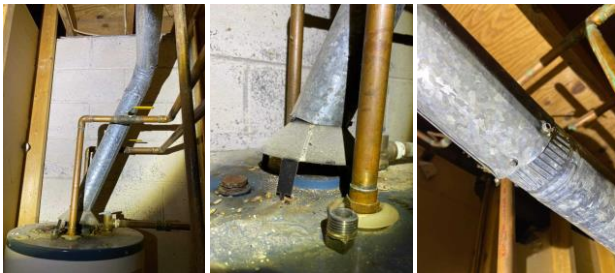
- 13. Marginal Flue Pipe: Single wall - Install screws at exhaust vent piping fittings- hat moves freely due to pipe angle. Seal joints.

3. Basement Water Heater Flue Pipe: Single wall - Install screws at exhaust vent piping fittings- hat moves freely due to pipe angle. Seal joints.

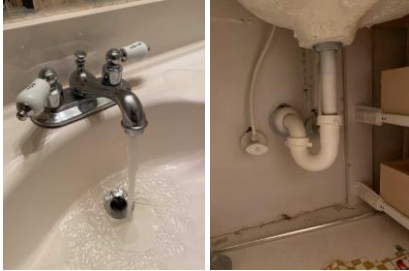
24. Marginal Faucets/Traps: Chrome fixtures with a PVC trap - Missing or faulty drain stopper

7. Upstairs back en-suite Bathroom Faucets/Traps: Chrome fixtures with a PVC trap - Missing or faulty drain stopper

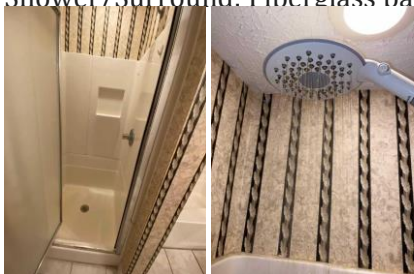
25. Defective Tub/Surround: Fiberglass tub and fiberglass surround - Tub spout is loose and moves, and swivels. This causes water to leak on tub faucet is turned on. Recommend further evaluation by licensed professional, to correct issue, to prevent water damage. Missing tub drain stopper.

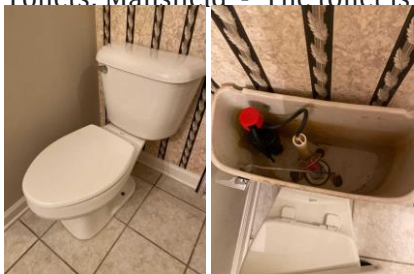
27. Defective Toilets: Mansfield - The toilet is loose at the floor and will require replacement of the wax seal

8. Upstairs back en-suite Bathroom Toilets: Mansfield - The toilet is loose at the floor and will require replacement of the wax seal

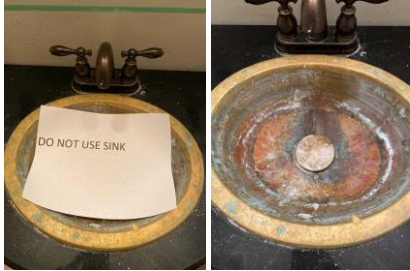
39. Not Inspected Faucets/Traps: Unable to test function of faucet, and drain line. There is a sign covering the sinks warning not to use.

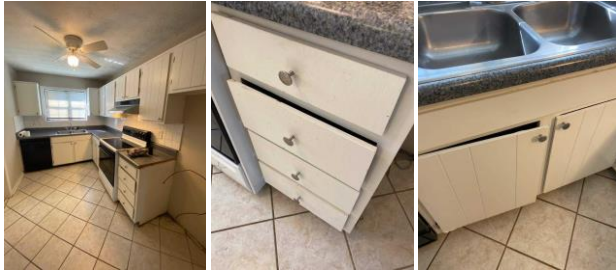
13. Marginal Cabinets: Wood - Older cabinets- some drawers and doors do not close properly and stay closed on their own.

12. 1st Floor Kitchen Cabinets: Wood - Older cabinets- some drawers and doors do not close properly and stay closed on their own.

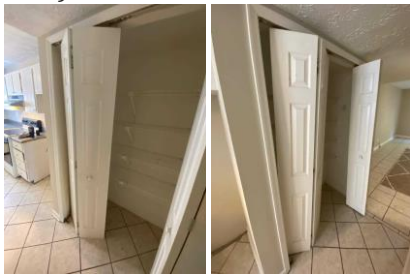
14. Defective Pantry: Single - Pantry bifold doors are inoperative. Left side door is broken, and will not stay on tracks. In need of correction.

10. 1st Floor Kitchen Pantry: Single - Pantry bifold doors are inoperative. Left side door is broken, and will not stay on tracks. In need of correction.

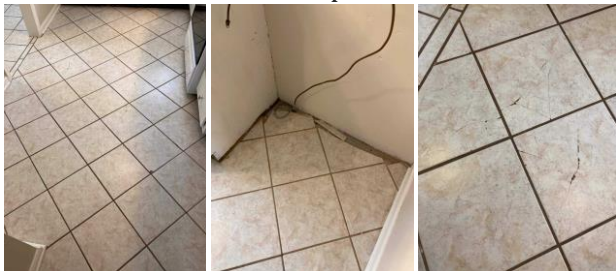
17. Defective Floor: Ceramic tile - Multiple broken floor tiles.

11. 1st Floor Kitchen Floor: Ceramic tile - Multiple broken floor tiles.

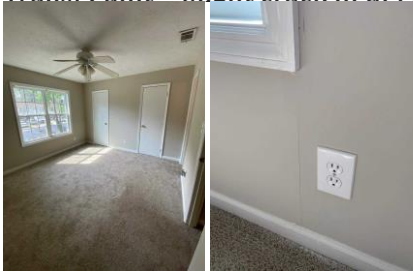
Walls: Paint - Slight crack in drywall at seam, under bottom right corner of window.

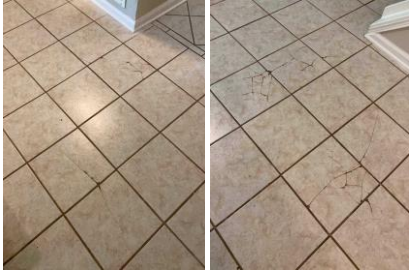
4. Defective Floor: Ceramic tile - Multiple floor tiles cracked and broken from what seems to be a major low spot in the floor.

1. Differential Movement: Cracking floors - Major dip in living room floor spanning across the entire room just outside of the kitchen. The dip is visibly seen, as well as multiple broken floor tiles along this area. This is most likely caused by a thin, sagging subfloor wood.

12. Family Room Living Space Floor: Ceramic tile - Multiple floor tiles cracked and broken from what seems to be a major low spot in the floor.

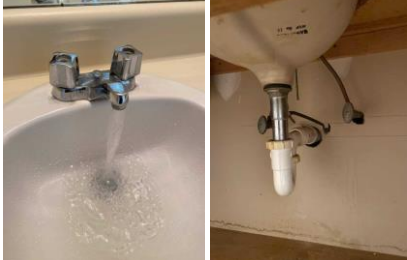
4. Unstairs front en-suite Bathroom Faucets/Traps: Chrome fixtures with a PVC trap - Missing or faulty drain stopper

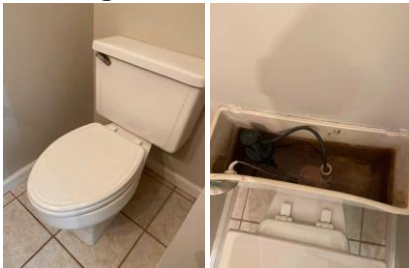
8. 1st floor main Half Bathroom Doors: Hollow wood - Lockset(s) not latching-requires adjustment
9. 1st floor main Half Bathroom Toilets: 3 Gallon Tank - Toilet flushes and refills, but very slowly. Inside of tank showing corrosion.

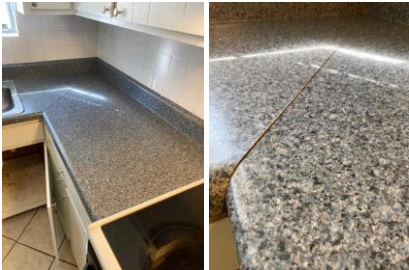
11. 1st Floor Kitchen Counter Tops: Laminate - Corner seam is not sealed properly, allowing water intrusion, and possible bacteria to grow. Needs caulking

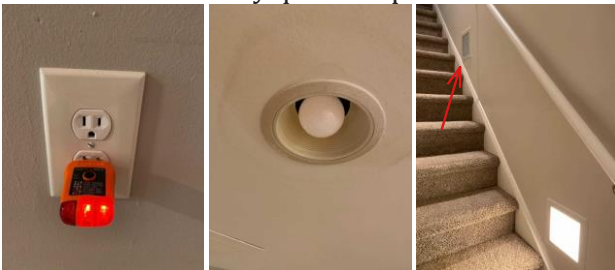
4. Main Basement Electrical: 110 VAC - Light fixture lighting basement stairwell, one of the two lights is not working, as well as the recessed light in the ceiling is not working properly. It will not turn all the way in flickers. Recommend further evaluation by qualified professional.

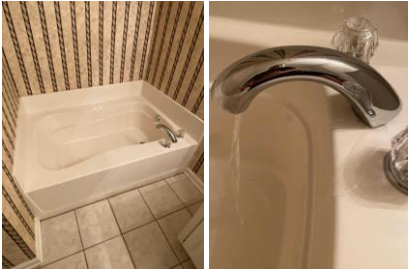
6. Upstairs back en-suite Bathroom Doors: Hollow wood - Lockset(s) not latching-requires adjustment
7. Upstairs back en-suite Bathroom Tub/Surround: Fiberglass tub and fiberglass surround - Tub spout is loose and moves, and swivels. This causes water to leak on tub faucet is turned on. Recommend further evaluation by licensed professional, to correct issue, to prevent water damage. Missing tub drain stopper.
